**Flood Control Project Maintenance  
Levee Inspections**  
**LMA District Cover Sheet**  
**Spring 2017 Levee Inspection Results**

**Sutter Maintenance Yard East-West Interceptor**

**Spring 2017 Levee Inspection Results**

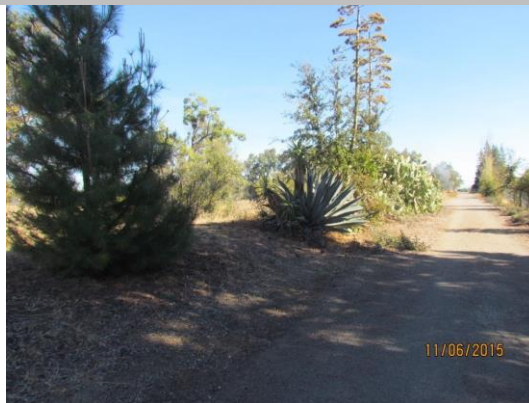
Photo 1 of 2 : SP\_2017\_ST0020\_213\_2\_20170315\_00002.jpg

View of the cactus and pine trees along the waterside berm.

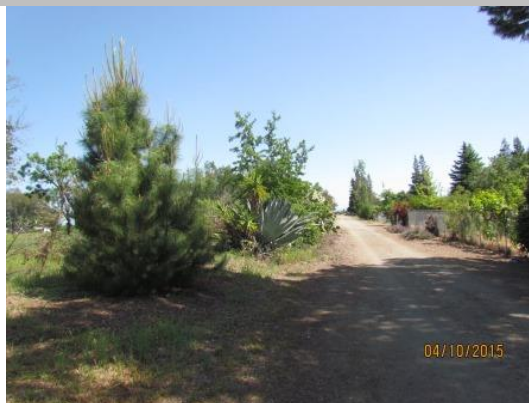
Photo 2 of 2 : SP\_2017\_ST0020\_213\_2\_20170315\_00003.jpg

Another view of the cactus and pine trees along the waterside berm.

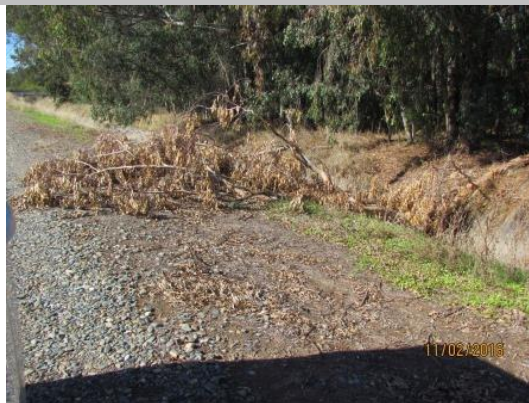
Photo 1 of 1 : SP\_2017\_ST0020\_213\_14\_20170315\_00010.jpg

LM Start	0.43	Rating **	M	Issue No.	14
LM End	0.43	Issue Type +	Ma	Location *	WS
Category	Earthen Levee			GPS Latitude/Longitude	
				Start	End
Item	Encroachments			39.171422 °	39.171422 °
				-121.751978 °	-121.751978 °
DWR ID	DWR_ST0020_01_f_2016_14				
Comment Code					
TR : Tree or limb					
Inspector Comment					
Remove the tree limb from the waterside.

View of a fallen limb.

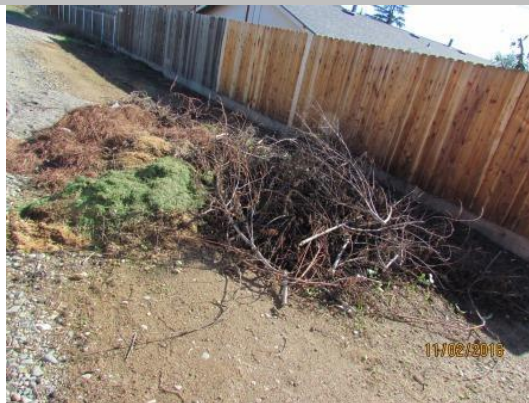
Photo 1 of 1 : SP\_2017\_ST0020\_213\_15\_20170315\_00011.jpg

View of the prunings along the landside toe.

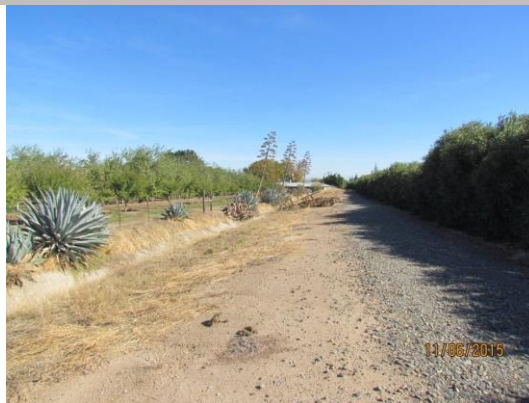
Photo 1 of 1 : SP\_2017\_ST0020\_213\_1\_20170315\_00001.jpg

View of the cactus tree that has fallen on the waterside slope.

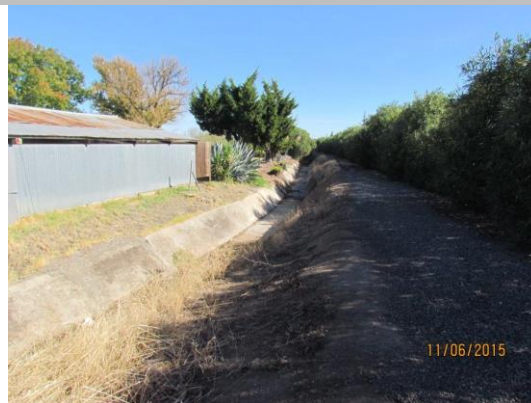
Photo 1 of 2 : SP\_2017\_ST0020\_213\_4\_20170315\_00004.jpg

LM Start	0.62	Rating **	U	Issue No.	4
LM End	0.65	Issue Type +	Ma	Location *	WS
Category	Earthen Levee			GPS Latitude/Longitude	
				Start	End
Item	Erosion / Bank Caving			39.171292 °	39.171232 °
				-121.748868 °	-121.748175 °
DWR ID	DWR_NA0020_01_s_2012_4				
Comment Code					
E2 : Schedule repair of erosion site prior to the next inspection.					
Inspector Comment					
Repair the erosion along the concrete ditch.

View the erosion along the concrete ditch.

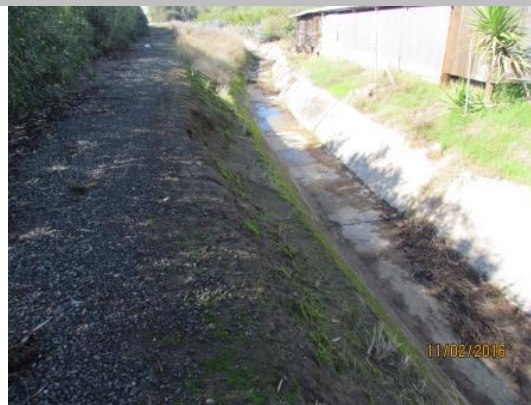
Photo 2 of 2 : SP\_2017\_ST0020\_213\_4\_20170315\_00005.jpg

Another view the erosion along the concrete ditch.

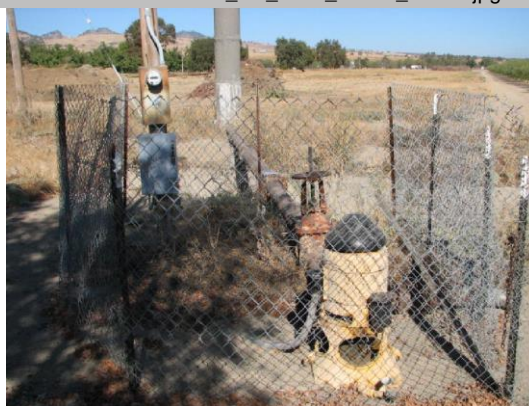
Photo 1 of 2 : UCIP\_SP\_2017\_51523\_11344.jpg

Comment Code					
Inspector Comment					
FS_ID:51523 DS_ID:19417 EP_NO: N/A Repair Type: Non-Urgent Crossing Status: Found UCIP Comments: 4/10/2017 Crossing appears to have been abandoned. (DWR Sutter Yard- A Freitag)4/19/2016 Meter has been removed from the power box and the power lines have been disconnected from the pole and pump. Appears this crossing may have been abandoned.5/12/2015 Crossing appears in good condition. No noticeable issues to report.11/17/2014 Same as last inspection.5/12/2014 Same as last inspection.11/4/2013 Same as last inspection.5/15/2013 Same as last inspection. FIELD_STRUCT_DESC: 12-inch steel irrigation pipe crosses over canal above crown elevation. Chain link enclosure on the landside (LS) with pump, power line, and shutoff valve. 24-inch concrete standpipe on unprotected side of canal. [Additional Reference(s): DWR Levee Log, Revised 1990] FS Date: 4/12/2017 10:54:51 AM

Pump, meter, power pole, slide gate, and chainlink fence on LS with 24-inch concrete standpipe on unprotected side of canal.

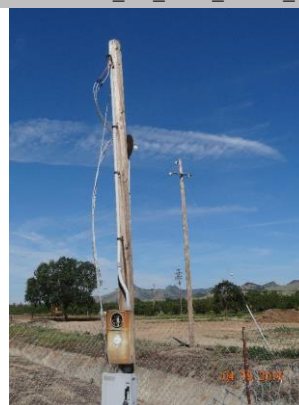
Photo 2 of 2 : UCIP\_SP\_2017\_51523\_74963.jpg

Meter removed from box and disconnected power lines

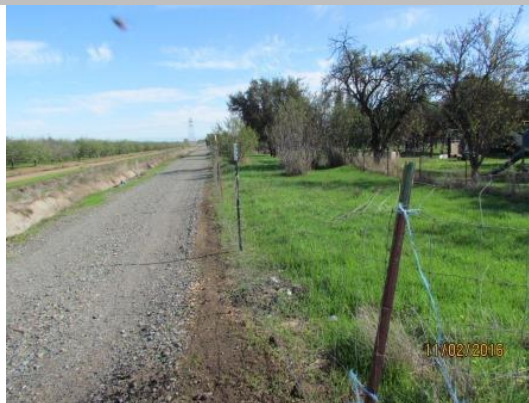
Photo 1 of 1 : SP\_2017\_ST0020\_213\_16\_20170315\_00012.jpg

View of an unauthorized fence by a landowner.

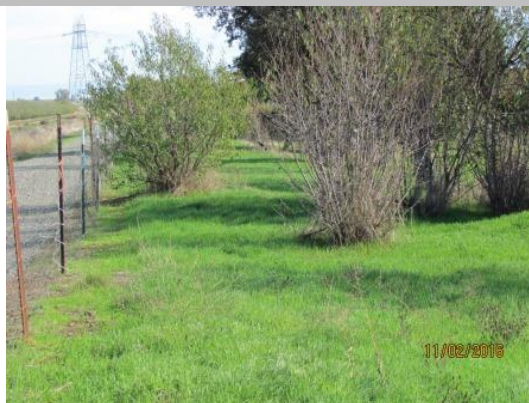
Photo 1 of 1 : SP\_2017\_ST0020\_213\_17\_20170315\_00013.jpg

LM Start	0.94	Rating **	M	Issue No.	17
LM End	0.98	Issue Type +	En	Location *	LS
Category	Earthen Levee			GPS Latitude/Longitude	
				Start	End
Item	Encroachments			39.171333 °	39.171333 °
				-121.742577 °	-121.741827 °
DWR ID	DWR_ST0020_01_f_2016_17				
Comment Code					
CR : Crops					
Inspector Comment					
Ask the landowner to remove the nut trees.

View of the nut trees planted by a landowner.

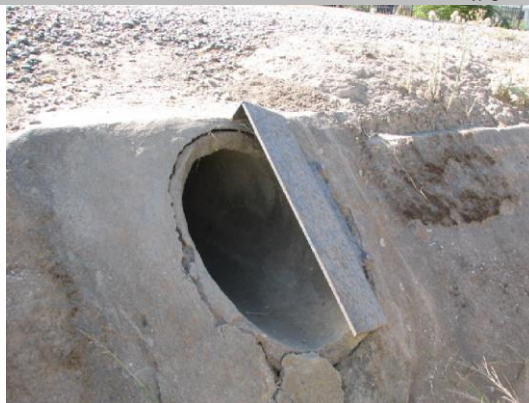
Photo 1 of 1 : UCIP\_SP\_2017\_51524\_11345.jpg

FS\_ID:51524  
DS\_ID:19434  
EP\_NO: 12746-1  
Repair Type: Non-Urgent  
Crossing Status: Found  
UCIP Comments: 4/10/2017 Overgrown vegetation blocking access to pipe. Could not be inspected. (DWR Sutter Yard-afreitag)10/11/2016 Crossing appears to be in good condition. Still no flapgate installed on the WS but unsure if its even necessary. (DWR Sutter Yard - afreitag)4/19/2016 Crossing appears to be in good condition. Still no flapgate installed on the WS but unsure if its even necessary. (DWR Sutter Yard - afreitag)5/12/2015 Still no flap gate on pipe end but i believe the LS inlet is high enough to not allow water to flow through pipe. (DWR Sutter Yard - afreitag)11/17/2014 Same as last inspection. (DWR Sutter Yard - afreitag)5/12/2014 Same as last inspection. (DWR Sutter Yard - afreitag)11/4/2013 Same as last inspection. (DWR Sutter Yard - afreitag)5/15/2013 Same as last inspection. (DWR Sutter Yard - afreitag)10/16/2012 There is no flap gate or other device to prevent water from flowing back through the pipe at the outlet. (DWR UCIP - wwylie)

Outlet in channel with steel deflector over pipe outlet.

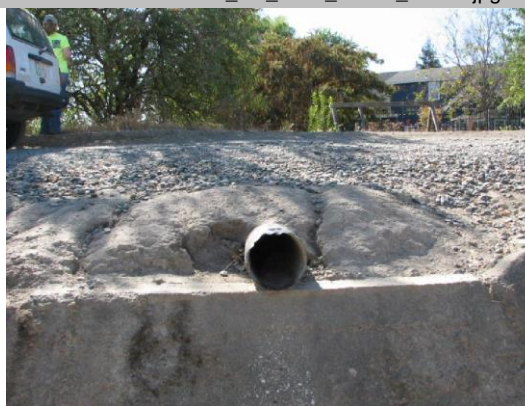
Photo 1 of 2 : UCIP\_SP\_2017\_51525\_64242.jpg

FS\_ID:51525  
DS\_ID:20115  
EP\_NO: N/A  
Repair Type: Non-Urgent  
Crossing Status: Found  
UCIP Comments: 4/10/217 Overgrown vegetation was blocking access to this pipe. It was not inspected. (DWR Sutter Yard-AFreitag)10/11/2016 Crossing appears to be in good condition.(DWR Sutter Yard - afreitag)4/19/2016 Crossing appears to be in good condition.5/12/2015 Crossing appears in good condition. No noticeable issues to report.11/17/2014 Same as last inspection.5/12/2014 New flapgate installed on WS pipe end.11/4/2013 Same as last inspection.5/15/2013 Same as last inspection.10/16/2012 Pipe not permitted and has no flap gate.  
FIELD\_STRUCT\_DESC: 8-inch corrugated metal drainage pipe through the levee, 1.5 feet below the crown. Outlet visible on the waterside (WS). Unable to locate the inlet on the landside (LS). No permit has been identified since crossing was field discovered in 2012.  
FS Date: 4/12/2017 10:57:08 AM

Pipe at outlet on WS crown.

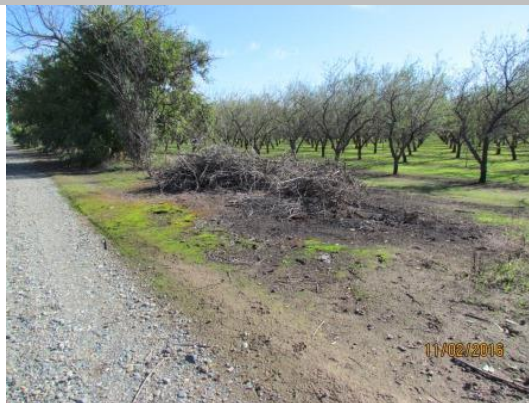
Photo 1 of 1 : SP\_2017\_ST0020\_213\_19\_20170315\_00015.jpg

View of the prunings along the landside toe.

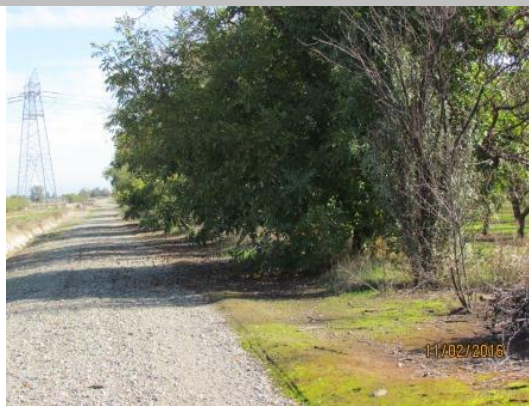
Photo 1 of 1 : SP\_2017\_ST0020\_213\_18\_20170315\_00014.jpg

LM Start	1.11	Rating **	M	Issue No.	18
LM End	1.28	Issue Type +	Ma	Location *	LS
Category	Earthen Levee			GPS Latitude/Longitude	
				Start	End
Item	Trim / Thin Trees			39.171283 °	39.171243 °
				-121.739315 °	-121.736312 °
DWR ID	DWR_ST0020_01_f_2016_18				
Comment Code					
T1 : Trim trees to at least five feet above ground level.					
Inspector Comment

View of the trees blocking visibility.

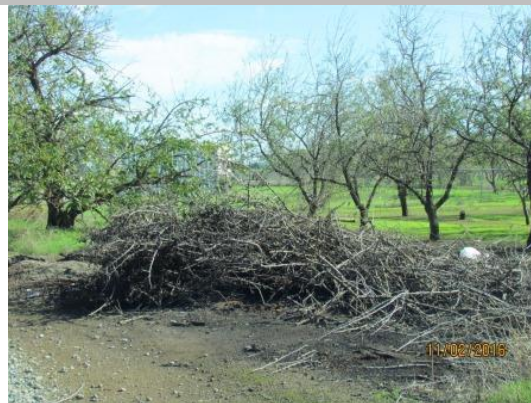
Photo 1 of 1 : SP\_2017\_ST0020\_213\_21\_20170315\_00016.jpg

View of the prunings along the landside toe.

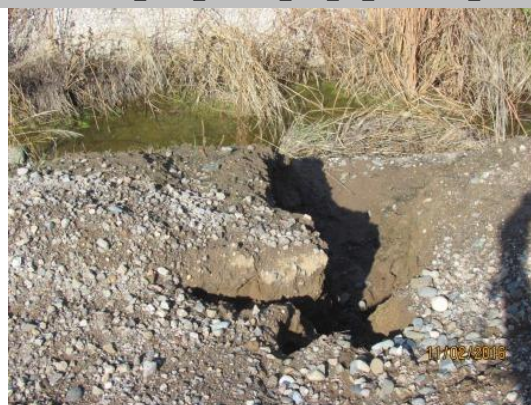
Photo 1 of 1 : SP\_2017\_ST0020\_213\_22\_20170315\_00017.jpg

LM Start	1.33	Rating **	M	Issue No.	22
LM End	1.33	Issue Type +	Ma	Location *	WS
Category	Earthen Levee			GPS Latitude/Longitude	
				Start	End
Item	Erosion / Bank Caving			39.171218 °	39.171218 °
				-121.735258 °	-121.735258 °
DWR ID	DWR_ST0020_01_f_2016_22				
Comment Code					
E1 : Note and monitor erosion site.					
Inspector Comment

View of the erosion along the bank.

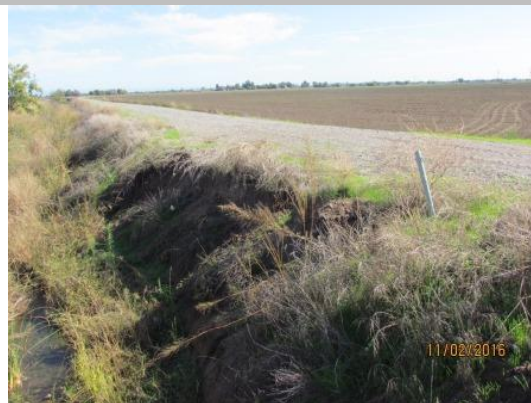
Photo 1 of 1 : SP\_2017\_ST0020\_213\_24\_20170315\_00018.jpg

LM Start	1.36	Rating **	M	Issue No.	24
LM End	1.36	Issue Type +	Ma	Location *	WS
Category	Earthen Levee			GPS Latitude/Longitude	
				Start	End
Item	Erosion / Bank Caving			39.171220 °	39.171220 °
				-121.734730 °	-121.734730 °
DWR ID	DWR_ST0020_01_f_2016_24				
Comment Code					
E1 : Note and monitor erosion site.					
Inspector Comment

View of the erosion along the bank.

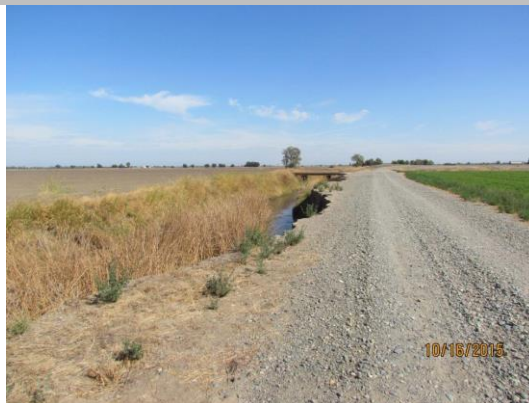
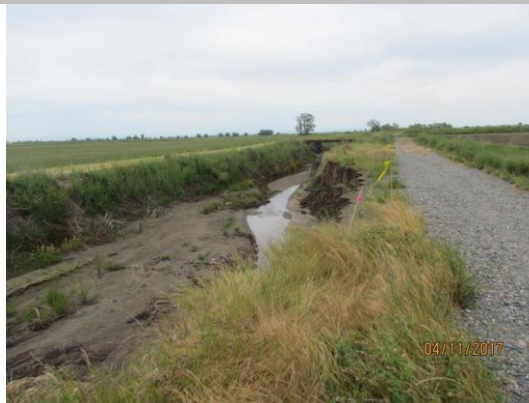
LM Start	1.65	Rating **	U	Issue No.	6
LM End	1.65	Issue Type +	Ma	Location *	WS
Category	Rivers, Channels & Designated Floodways			GPS Latitude/Longitude	
				Start	End
Item	Erosion / Bank Caving			39.171132 °	39.171132 °
				-121.729312 °	-121.729312 °
DWR ID	DWR_NA0020_01_s_2012_6				
Comment Code					
Inspector Comment					
Sutter Yard needs to repair the erosion before winter.

Repair the erosion along the waterside slope.

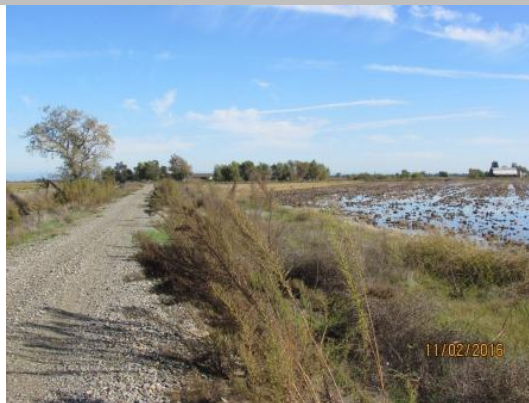
Photo 1 of 1 : SP\_2017\_ST0020\_214\_11\_20170315\_00010.jpg

View of the annual grass along the landside slope.

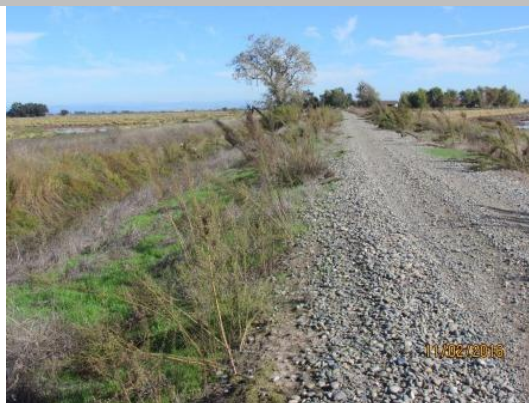
Photo 1 of 1 : SP\_2017\_ST0020\_214\_24\_20170315\_00012.jpg

LM Start	0.03	Rating **	M	Issue No.	24
LM End	0.25	Issue Type +	Ma	Location *	WS
Category	Earthen Levee			GPS Latitude/Longitude	
				Start	End
Item	Vegetation			39.171152°	39.171160°
				-121.725937°	-121.721673°
DWR ID	DWR_ST0020_02_f_2016_24				
Comment Code					
V1 : Control annual grass and weeds on the levee slopes and easements.					
Inspector Comment

View of the annual grass along the waterside slope.

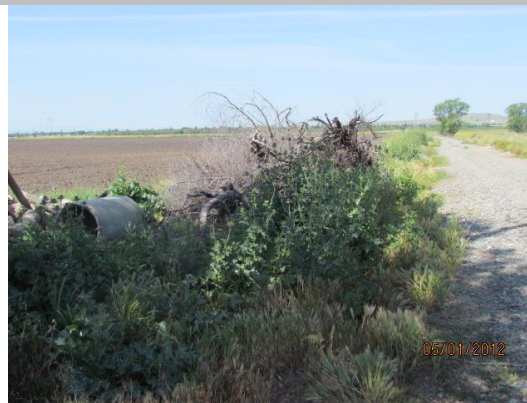
Photo 1 of 1 : SP\_2017\_ST0020\_214\_9\_20170315\_00008.jpg

View of the debris along the landside toe.

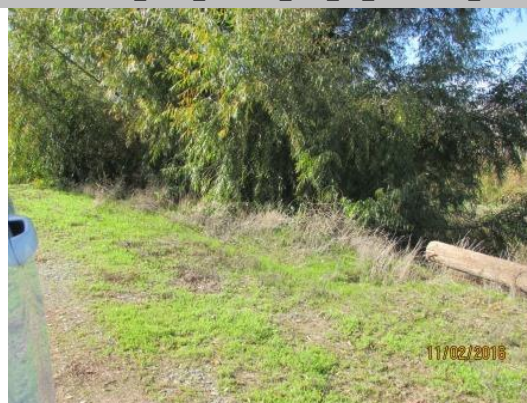
Photo 1 of 1 : SP\_2017\_ST0020\_214\_31\_20170315\_00014.jpg

View of the overgrown trees blocking visibility and access.

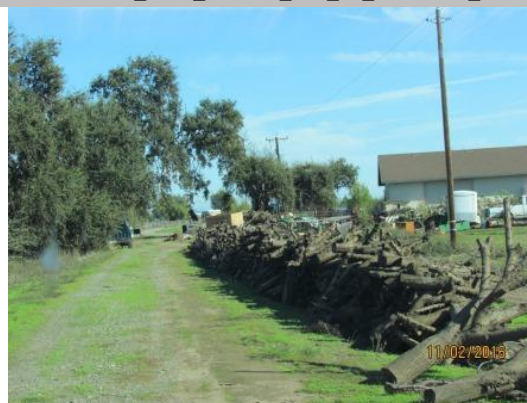
Photo 1 of 1 : SP\_2017\_ST0020\_214\_32\_20170315\_00015.jpg

View of the firewood along the landside toe.

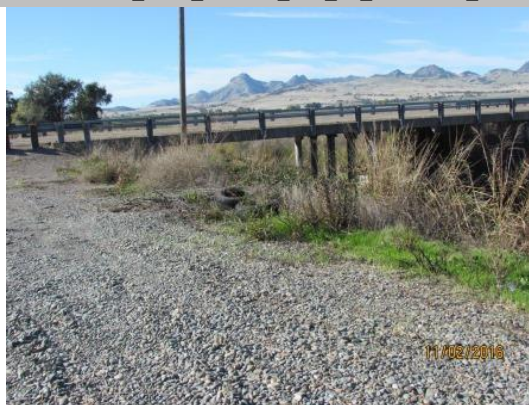
Photo 1 of 1 : SP\_2017\_ST0020\_214\_28\_20170315\_00013.jpg

View of the tires along the waterside berm.

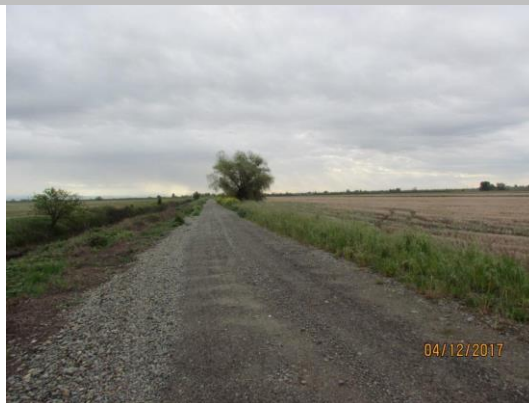
Photo 1 of 2 : SP\_2017\_ST0020\_214\_2\_20170413\_00045.jpg

View of the vegetation on landside slope.

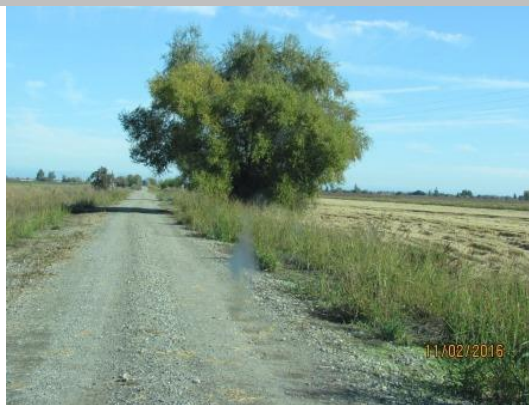
Photo 2 of 2 : SP\_2017\_ST0020\_214\_2\_20170315\_00001.jpg

View of the vegetation on both slopes.

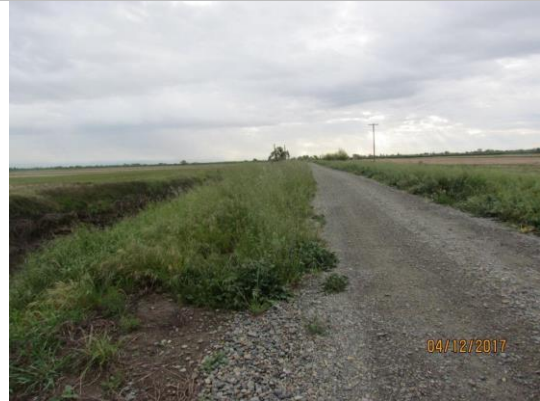
Photo 1 of 1 : SP\_2017\_ST0020\_214\_22\_20170413\_00046.jpg

View of the vegetation on the waterside slope.

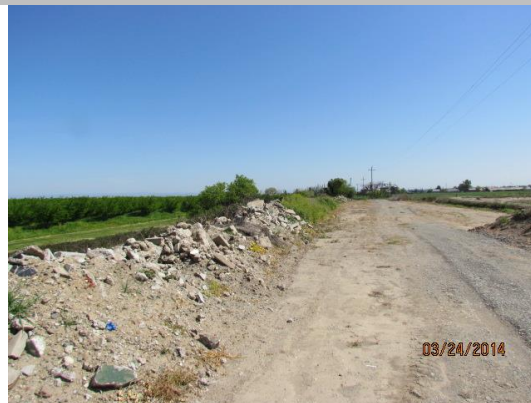
Photo 1 of 2 : SP\_2017\_ST0020\_214\_3\_20170315\_00002.jpg

LM Start	1.43	Rating **	M	Issue No.	3
LM End	1.52	Issue Type +	Ma	Location *	LS
Category	Earthen Levee			GPS Latitude/Longitude	
				Start	End
Item	Encroachments			39.170782 °	39.170865 °
				-121.700167 °	-121.698165 °
DWR ID	DWR_NA0020_02_s_2012_3				
Comment Code					
DE : Debris					
Inspector Comment					
Remove the broken concrete.

View of the piles of broken concrete.

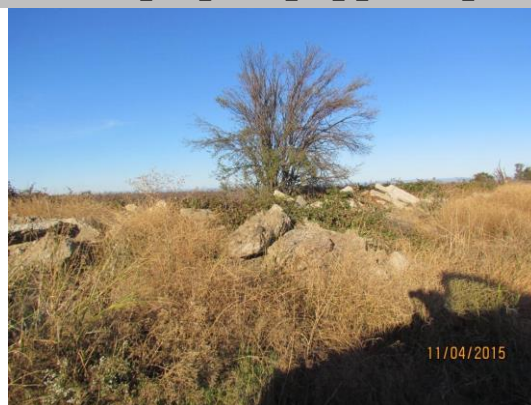
Photo 2 of 2 : SP\_2017\_ST0020\_214\_3\_20170315\_00003.jpg

View of the pile of broken concrete.

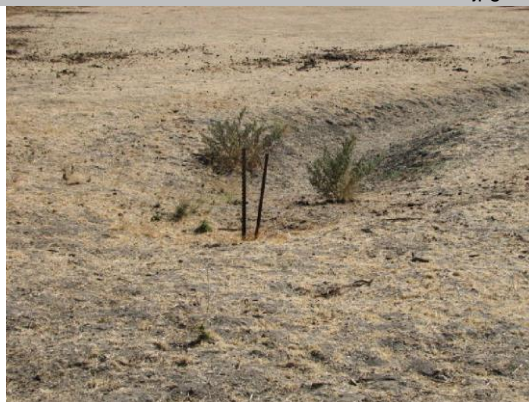
Photo 2 of 3 : UCIP\_SP\_2017\_51539\_11405.jpg

Comment Code					
Inspector Comment					
FS_ID:51539 DS_ID:19423 EP_NO: N/A Repair Type: Non-Urgent Crossing Status: Found UCIP Comments: 4/10/2017 LS inlet is buried, WS pipe outlet is overgrown wiht the flapgate being the only thing that is barely visible. (DWR Sutter Yard- AFreitag)10/11/2016 LS inlet is buried and WS flapgate is overgrown with blackberries.(DWR Sutter Yard - afreitag)4/19/2016 WS flapgate is completely overgrown with blackberries. 5/12/2015 LS inlet still buried with soil and blackberries on WS have blocked the flap gate.LS intake is filled and blocked with soil.11/17/2014 Ws outlet of pipe is overgrown and blocked from opening by blackberries. LS inlet still appears to be buried/blocked by soil.5/12/2014 Same as last inspection.11/4/2013 Same as last inspection.5/15/2013 Same as last inspection. FIELD_STRUCT_DESC: 16-inch corrugated metal drainage pipe through the levee, 5 feet below the crown. Flap gate located on the waterside (WS) end. Landside (LS) inlet filled and blocked with soil 2012. [Additional Reference(s): DWR Levee Log, Revised 1990] FS Date: 4/12/2017 12:07:34 PM

Buried inlet 30 feet from LS shoulder.

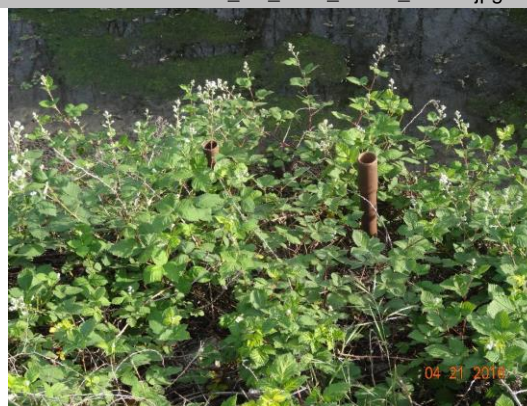
Photo 3 of 3 : UCIP\_SP\_2017\_51539\_74966.jpg

Comment Code						
Inspector Comment						
FS_ID:51539 DS_ID:19423 EP_NO: N/A Repair Type: Non-Urgent Crossing Status: Found UCIP Comments: 4/10/2017 LS inlet is buried, WS pipe outlet is overgrown wiht the flapgate being the only thing that is barely visible. (DWR Sutter Yard- AFreitag)10/11/2016 LS inlet is buried and WS flapgate is overgrown with blackberries.(DWR Sutter Yard - afreitag)4/19/2016 WS flapgate is completely overgrown with blackberries. 5/12/2015 LS inlet still buried with soil and blackberries on WS have blocked the flap gate.LS intake is filled and blocked with soil.11/17/2014 Ws outlet of pipe is overgrown and blocked from opening by blackberries. LS inlet still appears to be buried/blocked by soil.5/12/2014 Same as last inspection.11/4/2013 Same as last inspection.5/15/2013 Same as last inspection. FIELD_STRUCT_DESC: 16-inch corrugated metal drainage pipe through the levee, 5 feet below the crown. Flap gate located on the waterside (WS) end. Landside (LS) inlet filled and blocked with soil 2012. [Additional Reference(s): DWR Levee Log, Revised 1990] FS Date: 4/12/2017 12:07:34 PM

WS flapgate overgrown by blackberries

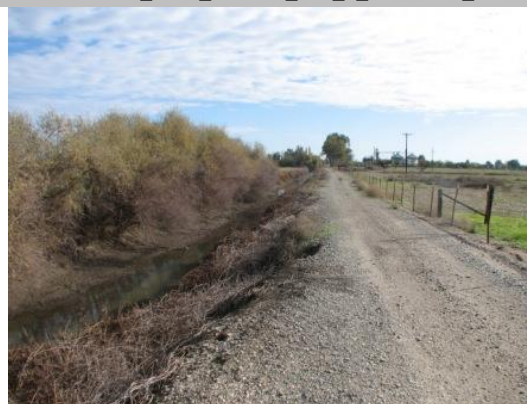
Photo 1 of 2 : SP\_2017\_ST0020\_214\_4\_20170315\_00004.jpg

View of the erosion along the waterside slope.

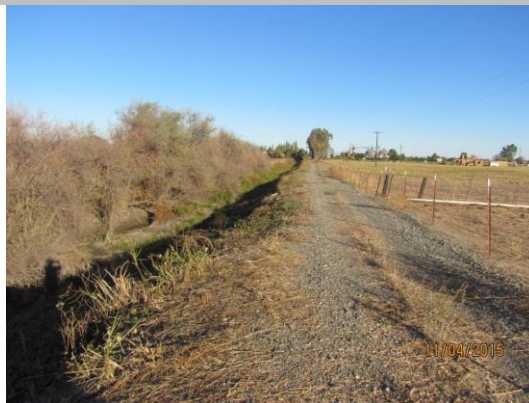
Photo 2 of 2 : SP\_2017\_ST0020\_214\_4\_20170315\_00005.jpg

View of the erosion along the waterside slope.

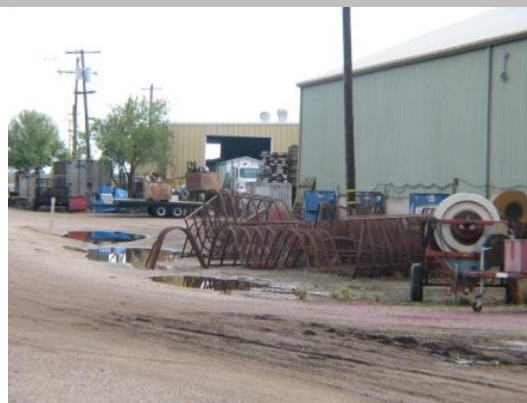
Photo 1 of 1 : SP\_2017\_ST0020\_214\_5\_20170315\_00006.jpg

View of the equipment and buildings next to the landside berm.

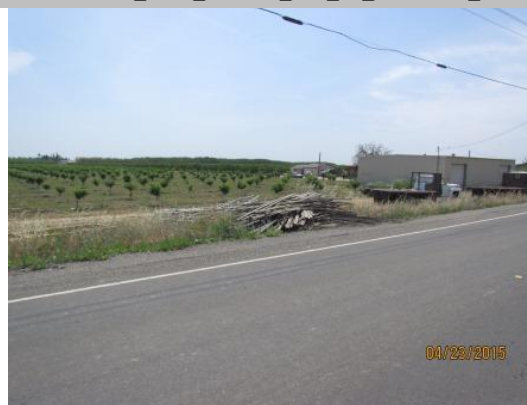
Photo 1 of 1 : SP\_2017\_ST0020\_214\_10\_20170315\_00009.jpg

View of the material, garbage, and equipment along the landside toe
